Manhole Inspection Summary

Manhole # S37W1_025MH

Location Address: **103 E Patapsco Ave**

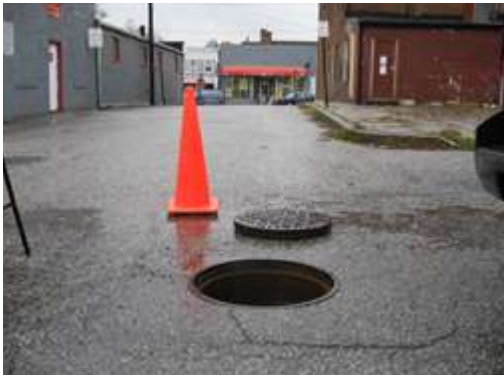
Location View

2nd Hanover

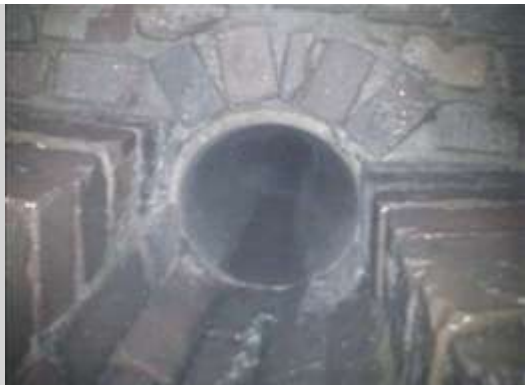
6 O'Clock Inflow

8 in. Circular Gravity Sewer
Pipe In @ 6 O'Clock

Pipe Height: **8.4** (in.) Rod and Bar (Angled)
Pipe Material: **Clay** ☐ Pipe Lined
Invert Depth: **10.50** (ft.) Flow Characteristics: **None**
Deposits: ☒ None ☐ Mud ☐ Sludge ☐ Debris ☐ Grease
Silt Depth: (in.) Deposits Extent:
Infiltration: **None** Pipe Seal Cond: **Sound**

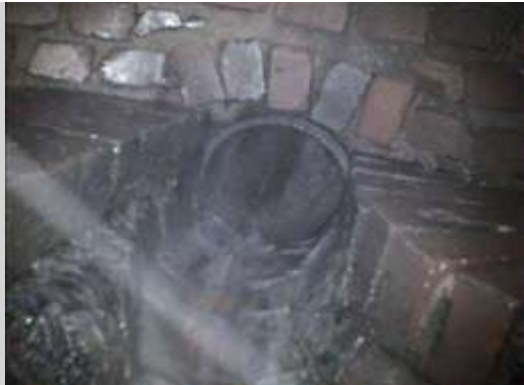
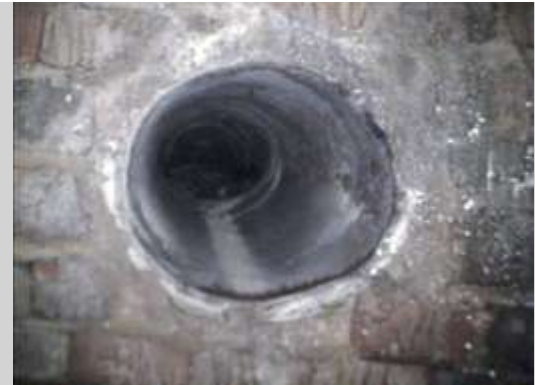
9 O'Clock Inflow

Pipe In @ 9 O'Clock

Drop In @ 9 O'Clock

Pipe Height: **4.8** (in.) Rod and Bar (Angled)

Pipe Material: **DIP/CI** ☐ Pipe Lined

Infiltration: **None** Pipe Seal Cond: **Sound**

Drop Condition: **Open**
